Safer radiotherapy

Radiotherapy error and near miss reporting: the unseen pathway

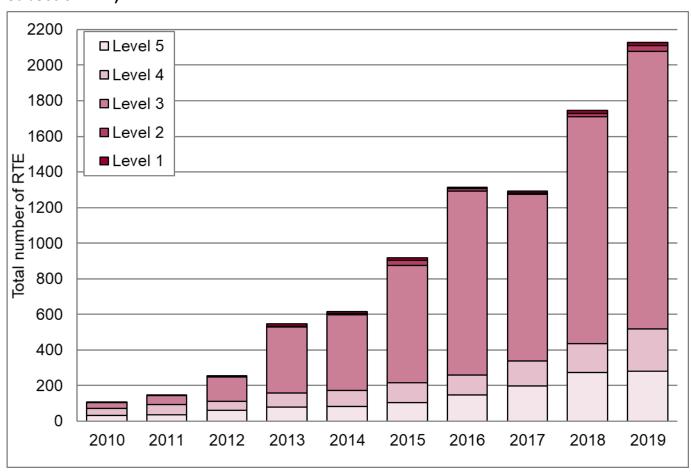
Figure 1. Reported unseen pathway RTE per year Aug 2009 to June 2020 (n = 9,078/9,680 subset of RTE)

The number of RTE associated with the unseen pathway has increased since 2009 (Figure 1). This increase mirrors the growth of mature reporting cultures seen across providers and the RT pathway for the overall period. Furthermore, the complexity of techniques and technologies used in radiotherapy has increased since 2009 with additional QA and imaging undertaken which may have had an impact on reporting levels. While there has been an increase in number of reports the proportion of level 1 reports has reduced. The proportion of level 1 RTE reports peaked in 2011 and 2012 at 2.7% and was at 0.9% in 2018 and 2019. No level 1 RTE reports were received in the first 6 months of 2020.

RTE from 2009 (n = 3) and 2020 (n = 599) were excluded from Figure 1 as they do not include a full year of data. However, in January 2021 the average number of monthly reports of RTE associated with the unseen pathway was calculated for the entire year of 2020 at 92 reports. This was 99.8 for the first 6 months of 2020, which includes the data in this analysis. This is considerably less than the 177.4 RTE month average of the year 2019.

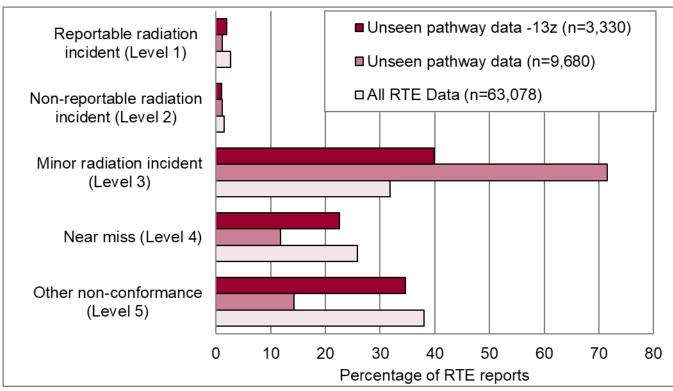
Each of the 9,680 RTE reports was classified by severity of the event as 'other non-conformance (Level 5)', 'near miss (Level 4)', 'minor radiation incident (Level 3)', 'non-reportable radiation incident (Level 2)' or 'reportable radiation incident (Level 1)'. Figure 2 includes data for the unseen pathway associated RTE presented against all RTE reports for the same time period.

There are differences in the spread of reported classification levels of unseen pathway RTE reports and all RTE as seen in Figure 2.

A higher percentage of RTE were classified as minor radiation incidents (Level 3) across RTE associated with the unseen pathway (71.6%, n = 6,929) than all Level 3 RTE reports (31.9%, n = 20,102). This is due to the inclusion of the pathway code 13z 'on-set imaging production process'. These events were identified as part of 'equipment failure'. They accounted for 6,350 of all RTE associated with the unseen pathway, the majority of which were coded as level 3 RTE, which skewed the results. An example of this type of RTE includes CBCT faults during acquisition leading to an additional verification exposure for a patient. During a previous review of all 'on-set imaging – production process' RTE it was found that 53.2% were attributed to equipment malfunction. If all 13z reports were removed from the analysis the unseen pathway data would be more comparable with the entire dataset. Further guidance on mitigating and reporting 13z onset imaging production process RTE can be seen in the PHE good practice guidance series (11) and Safer RT Triannual RTE analysis (12). For this reason, the RTE pathway code (13z) 'on-set imaging production process', irrespective of classification level, has been removed from further analysis within this report.

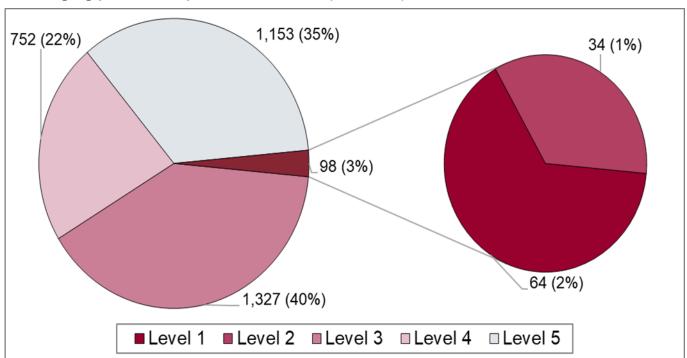
Of the RTE reports (with (13z) reports removed) 97.1% (n = 3,232) were minor radiation (Level 3), near miss (Level 4) or other non-conformities (Level 5) with little or no impact on patient outcome. 1.0% (n=34) of the total were 'reportable radiation incident (Level 1)' (Figure 3).

Figure 3. Classification (level) of RTE reports. Unseen pathway RTE with 13z 'on-set imaging production process' removed (n = 3,330)

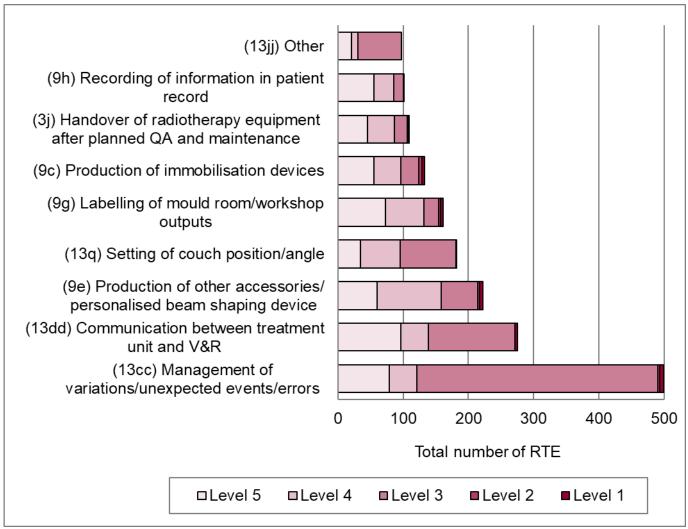
The most frequently reported process subcodes in the RT pathway associated with the unseen pathway are presented in Figure 4. This subset of data was also broken down by level with the greatest proportion of RTE falling in level 3 (minor radiation incidents). As discussed above this does not include (13z) 'on-set imaging production process'.

The reports were spread across a total of 132 pathway activities or subcodes. The most frequently occurring RTE reported was 'management of variations, unexpected events or errors' at 15.0% (n = 499). This is discussed further in Case Study A, within this report. The second most frequently occurring RTE was 'communication between treatment unit and V&R' at 8.3% (n = 275), discussed further in Case Study B.

Figure 4. Breakdown of most frequently reported RTE process subcodes by level (n = 1,682/3,330 subset of RTE)

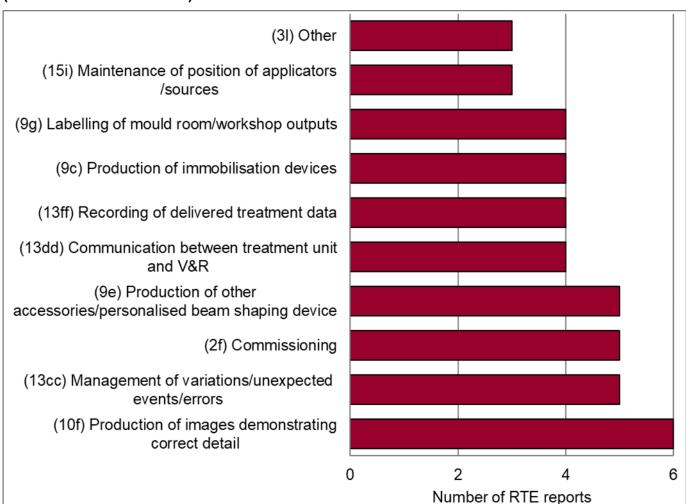
There were 64 reportable radiation incidents included for this reporting period, comprising 1.9% of the RTE reviewed. Further analysis of the reports indicates the points in the pathway at which the reportable incidents occurred (Figure 5).

Figure 5. Breakdown of most frequently reported level 1 RTE by process subcode (n = 43/64 subset of RTE)

The reports were spread across 30 different pathway activities or subcodes. 'Production of images demonstrating correct details', comprised 9.4% (n = 6) and was the most frequently occurring event within the reportable radiation incidents. An example of this type of RTE includes the CT planning scan terminating part way through a 4DCT scan. Mitigations for this type of RTE include reviewing equipment and QA and maintenance programme and training staff to understand frequent equipment malfunctions. Further mitigations include reviewing this type of malfunction and reporting to both manufacturers and the MHRA.

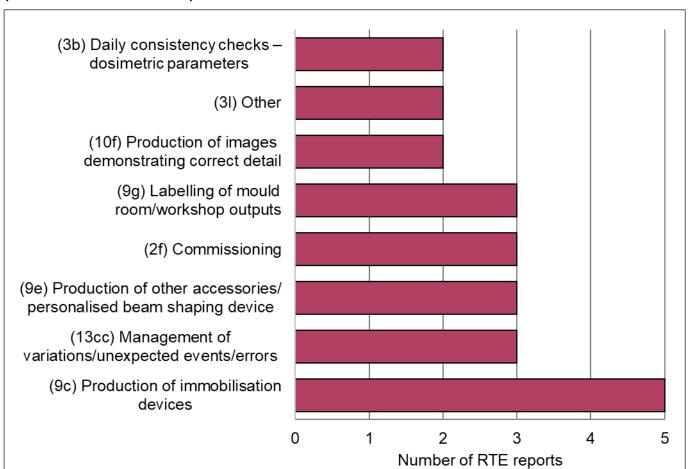
Non-reportable radiation incidents (Level 2) comprised 0.7 % (n = 23) of the RTE reported for this time period. Further analysis indicates the points in the pathway at which non-reportable radiation incidents occurred (Figure 6).

Figure 6. Breakdown of most frequently reported level 2 RTE by process subcode (n = 23/34 subset of RTE)

The reports were spread across just 19 different subcodes. 'Production of immobilisation devices' comprised 14.7% (n = 5) and was the most frequently occurring event within the non-reportable radiation incidents. An example of this type of RTE includes the incorrect production of a mouth bite leading to addition CT planning scans or the deflating of a vacuum fixed bag which led to multiple verification images or the replanning of treatment. Mitigation for this type of RTE include ensuring standard mouth bite designs are used where possible and appropriate instructions are available for the manufacturing of immobilisations devices.

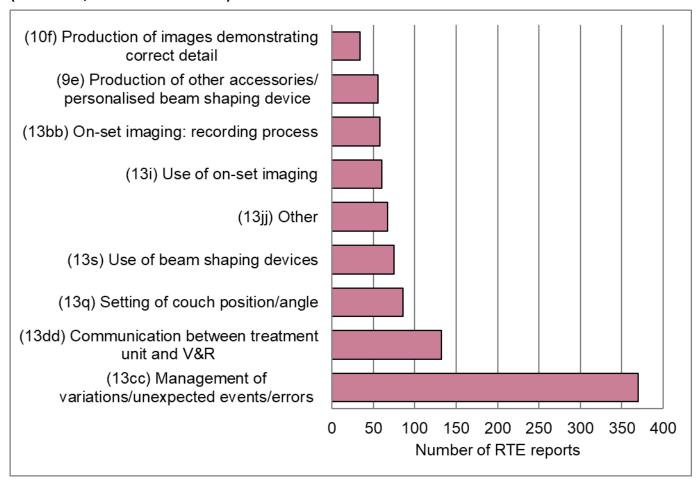
Minor radiation incidents comprised 39.8% (n = 1,327) of the RTE reported for this reporting period. A breakdown of most frequently reported level 3 RTE by process subcode can be seen in Figure 7. These reports were spread across 75 different pathway activities or subcodes.

Figure 7. Breakdown of most frequently reported level 3 RTE by process subcode (n = 938/1,327 subset of RTE)

'Management of variations, unexpected events or errors' was the most frequently occurring event (27.9%, n = 370) within this subset. Case study A contains further information on this type of RTE.

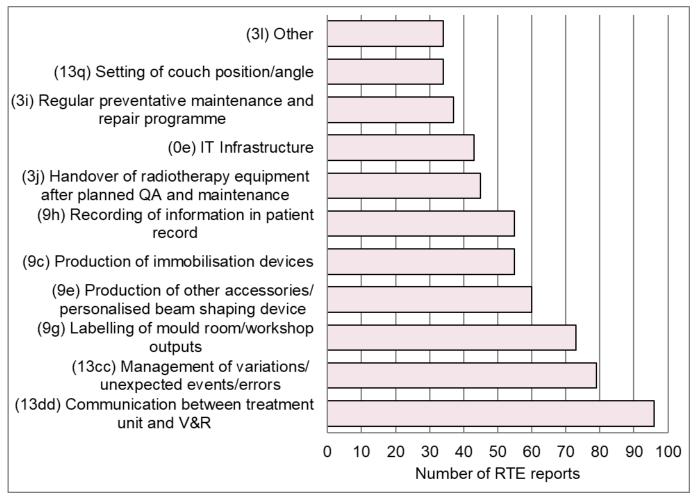
Level 5 RTE comprised 34.6% (n = 1,153) of all RTE reported for this period. Reports were spread across 109 pathway activities or process subcodes. The most frequently reported level 5 process subcode was 'communication between treatment unit and V&R' (8.3%, n = 96), (Figure 9). This is discussed further in Case Study B.

This was followed by 'management of variations, unexpected events or errors' (discussed as part of Case Study A) and 'labelling of mould room or workshop outputs. Accurate and clear labelling of mould room outputs is key to mitigating these events. Also ensuring the labelling is permanent is important so that stickers do not fall off or ink marks accidentally smudged or rendered illegible over time.

Figure 9. Breakdown of most frequently reported level 5 RTE by process subcode (n = 611/1,153 subset of RTE)

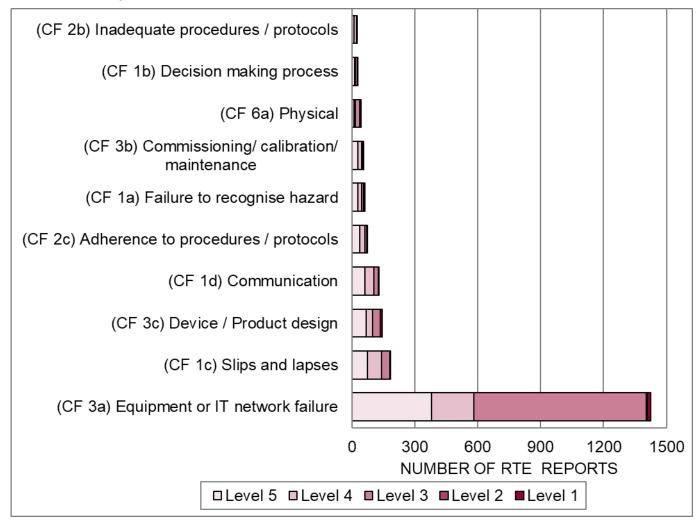
Figure 10 shows the most frequently reported primary causative factors which are the root cause (RC) of an incident. The most frequently reported RC was individual 'equipment failure' (64.4%, n = 1,424), followed by 'slips and lapses' (8.3%, n = 184). When compared to data across the entire pathway code the most frequently assigned RC is 'slips and lapses'. This difference in RC is reflective of the pathway activities providing the focus for this analysis. Typical examples of 'equipment failure' RTE reports included OMS loss of connection or communication with treatment machine or linac, server failure, DICOM faults, OMS crash or freeze, MLC fault and treatment machine fault.

Figure 10. Breakdown of most frequently reported RC by level (n = 2,164/2,210 subset of data)
